**Contamination Screening Evaluation Report  
State Road 426 / County Road 419  
From Pine Avenue to Lockwood Boulevard  
Oviedo, Seminole County, Florida**

September 23, 2003  
File No. 02-6521

Subject: Contamination Screening Evaluation Report  
State Road 426 / County Road 419  
From Pine Avenue to Lockwood Boulevard  
Oviedo, Seminole County, Florida

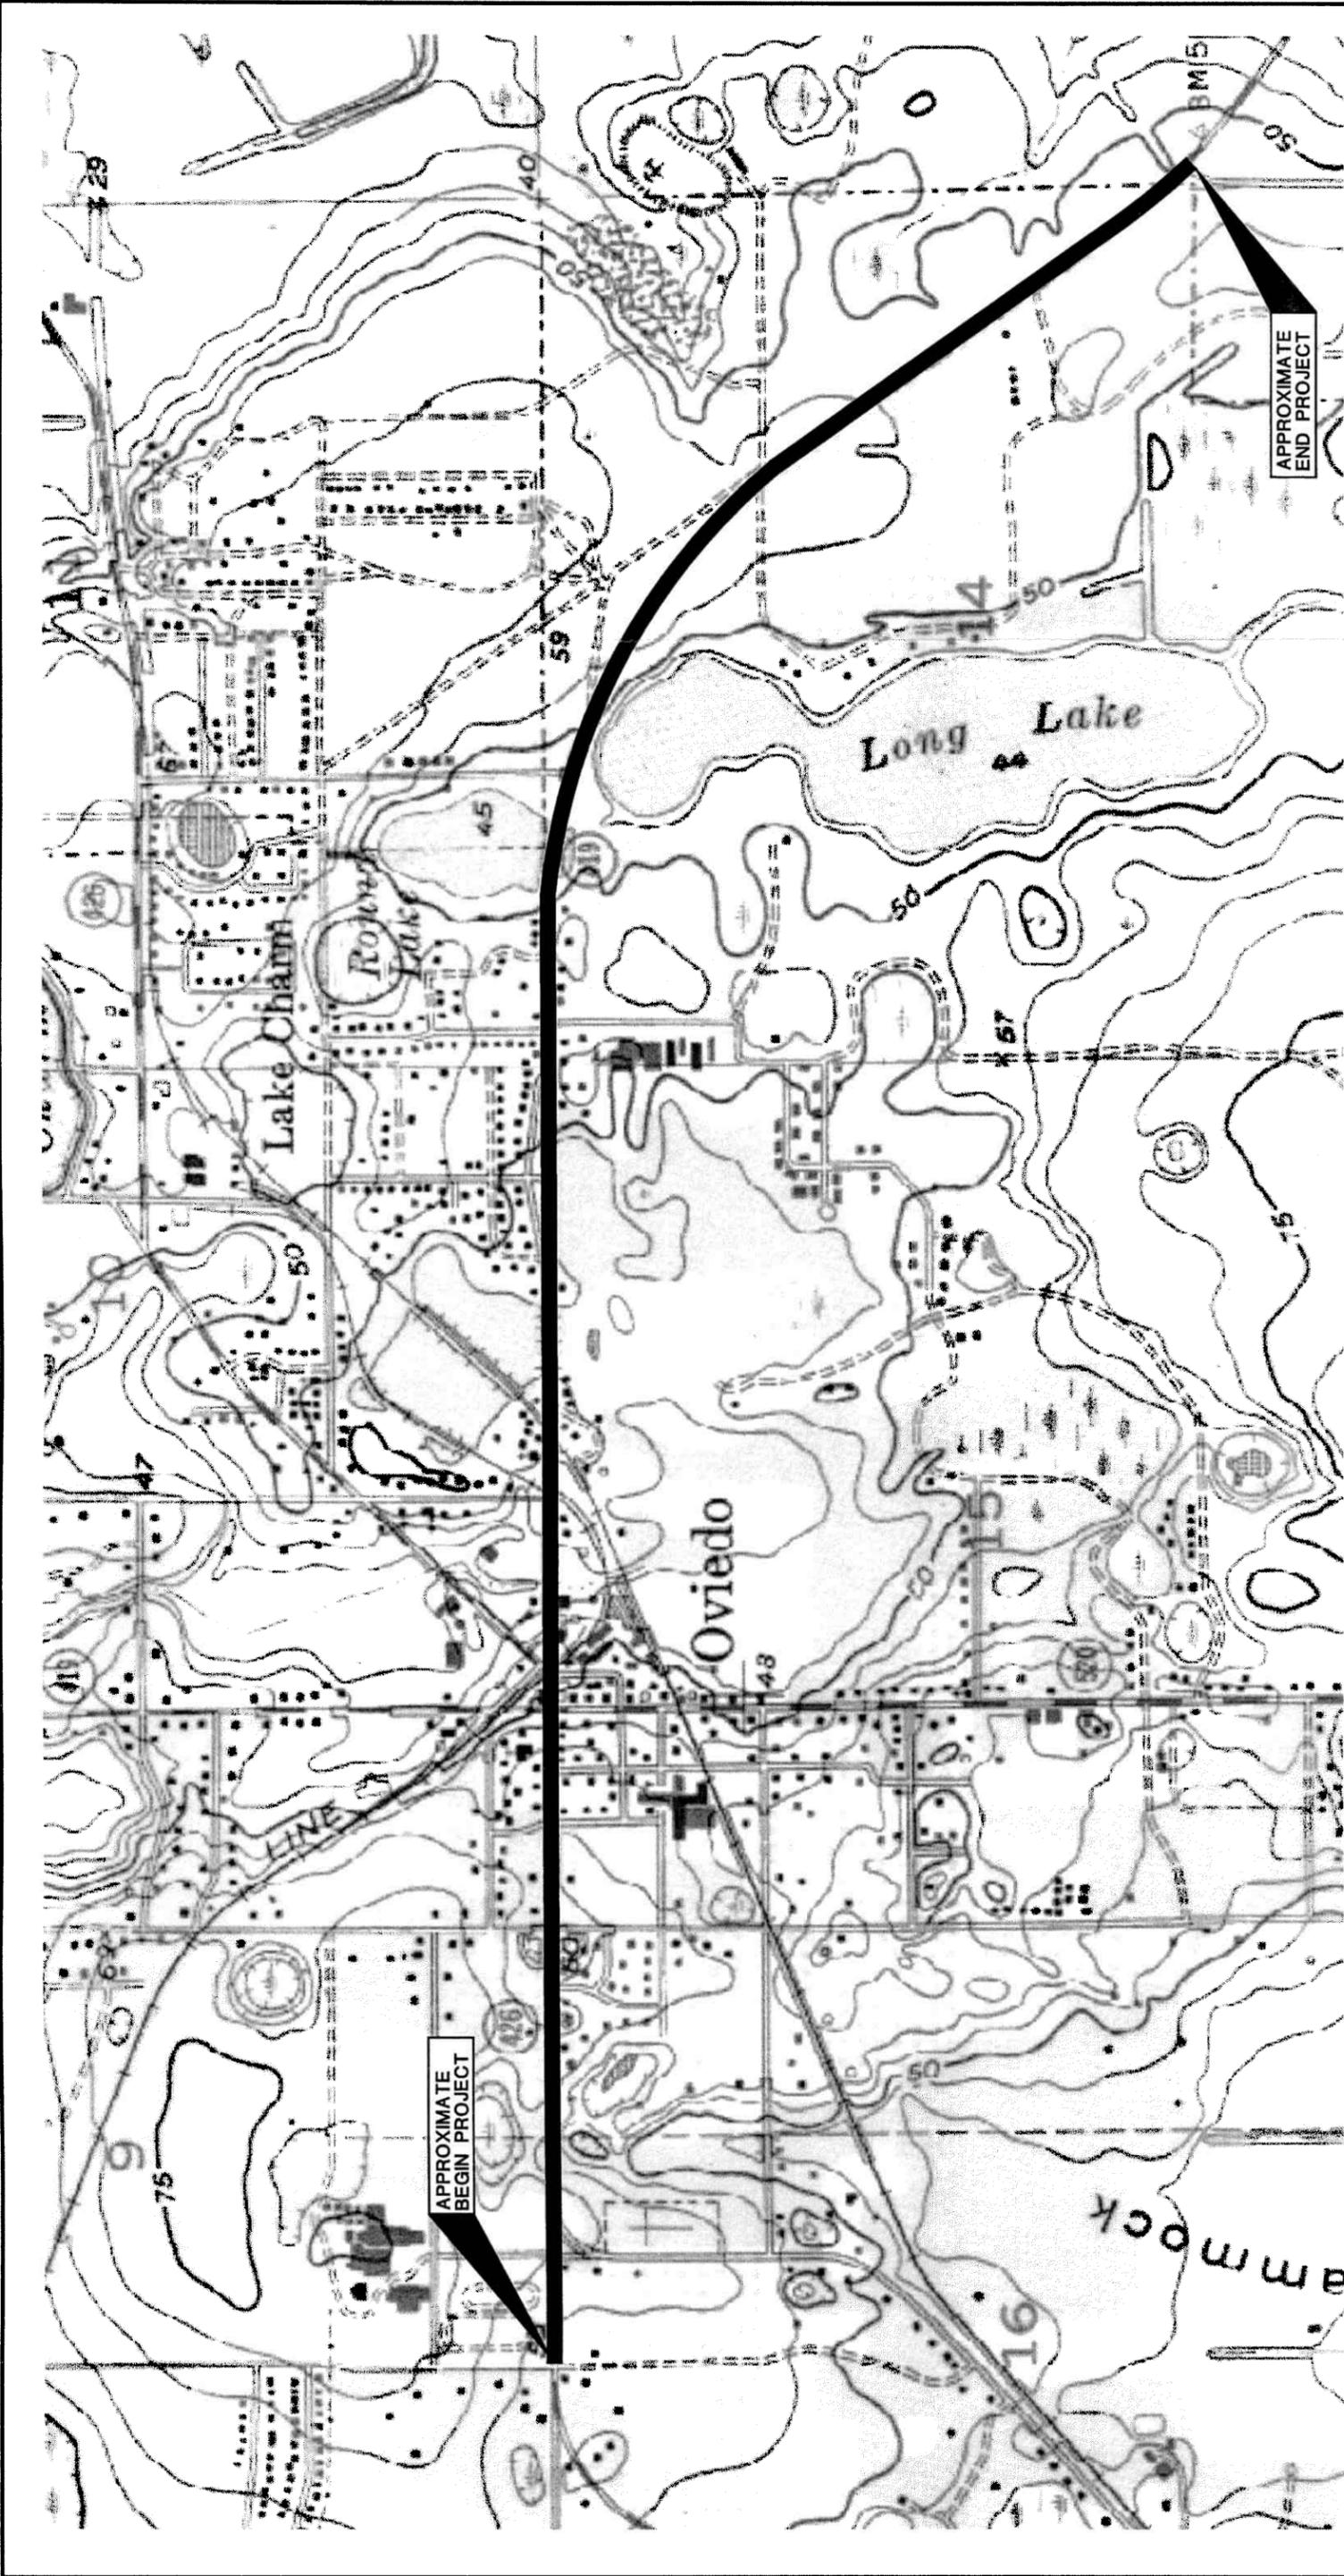
DRAWN BY: CD	CHECKED BY:	DATE: 09/22/03
FILE NO. 02-8521	APPROVED BY:	FIGURE: 1

Based on information provided by DRMP, Inc., it is our understanding that the project corridor under consideration for this study begins at the intersection of Pine Avenue and State Road 426 and terminates at the intersection of Lockwood Boulevard and County Road 419. The project corridor is located within Sections 9, 10, 11, 13 and 14 of Township 21 South, Range 31 East, in Seminole County, Florida. The approximate project location is shown superimposed on a reproduction of the Oviedo, Florida USGS quadrangle map presented as the site location map, Figure 1.

SECTIONS 9, 10, 11, 13, AND 14  
TOWNSHIP 21 SOUTH  
RANGE 31 EAST

BASE MAP: USGS 7.5-MINUTE TOPOGRAPHIC QUADRANGLE MAP, OVIEDO, FLA., 1956  
PHOTOREVISED 1980

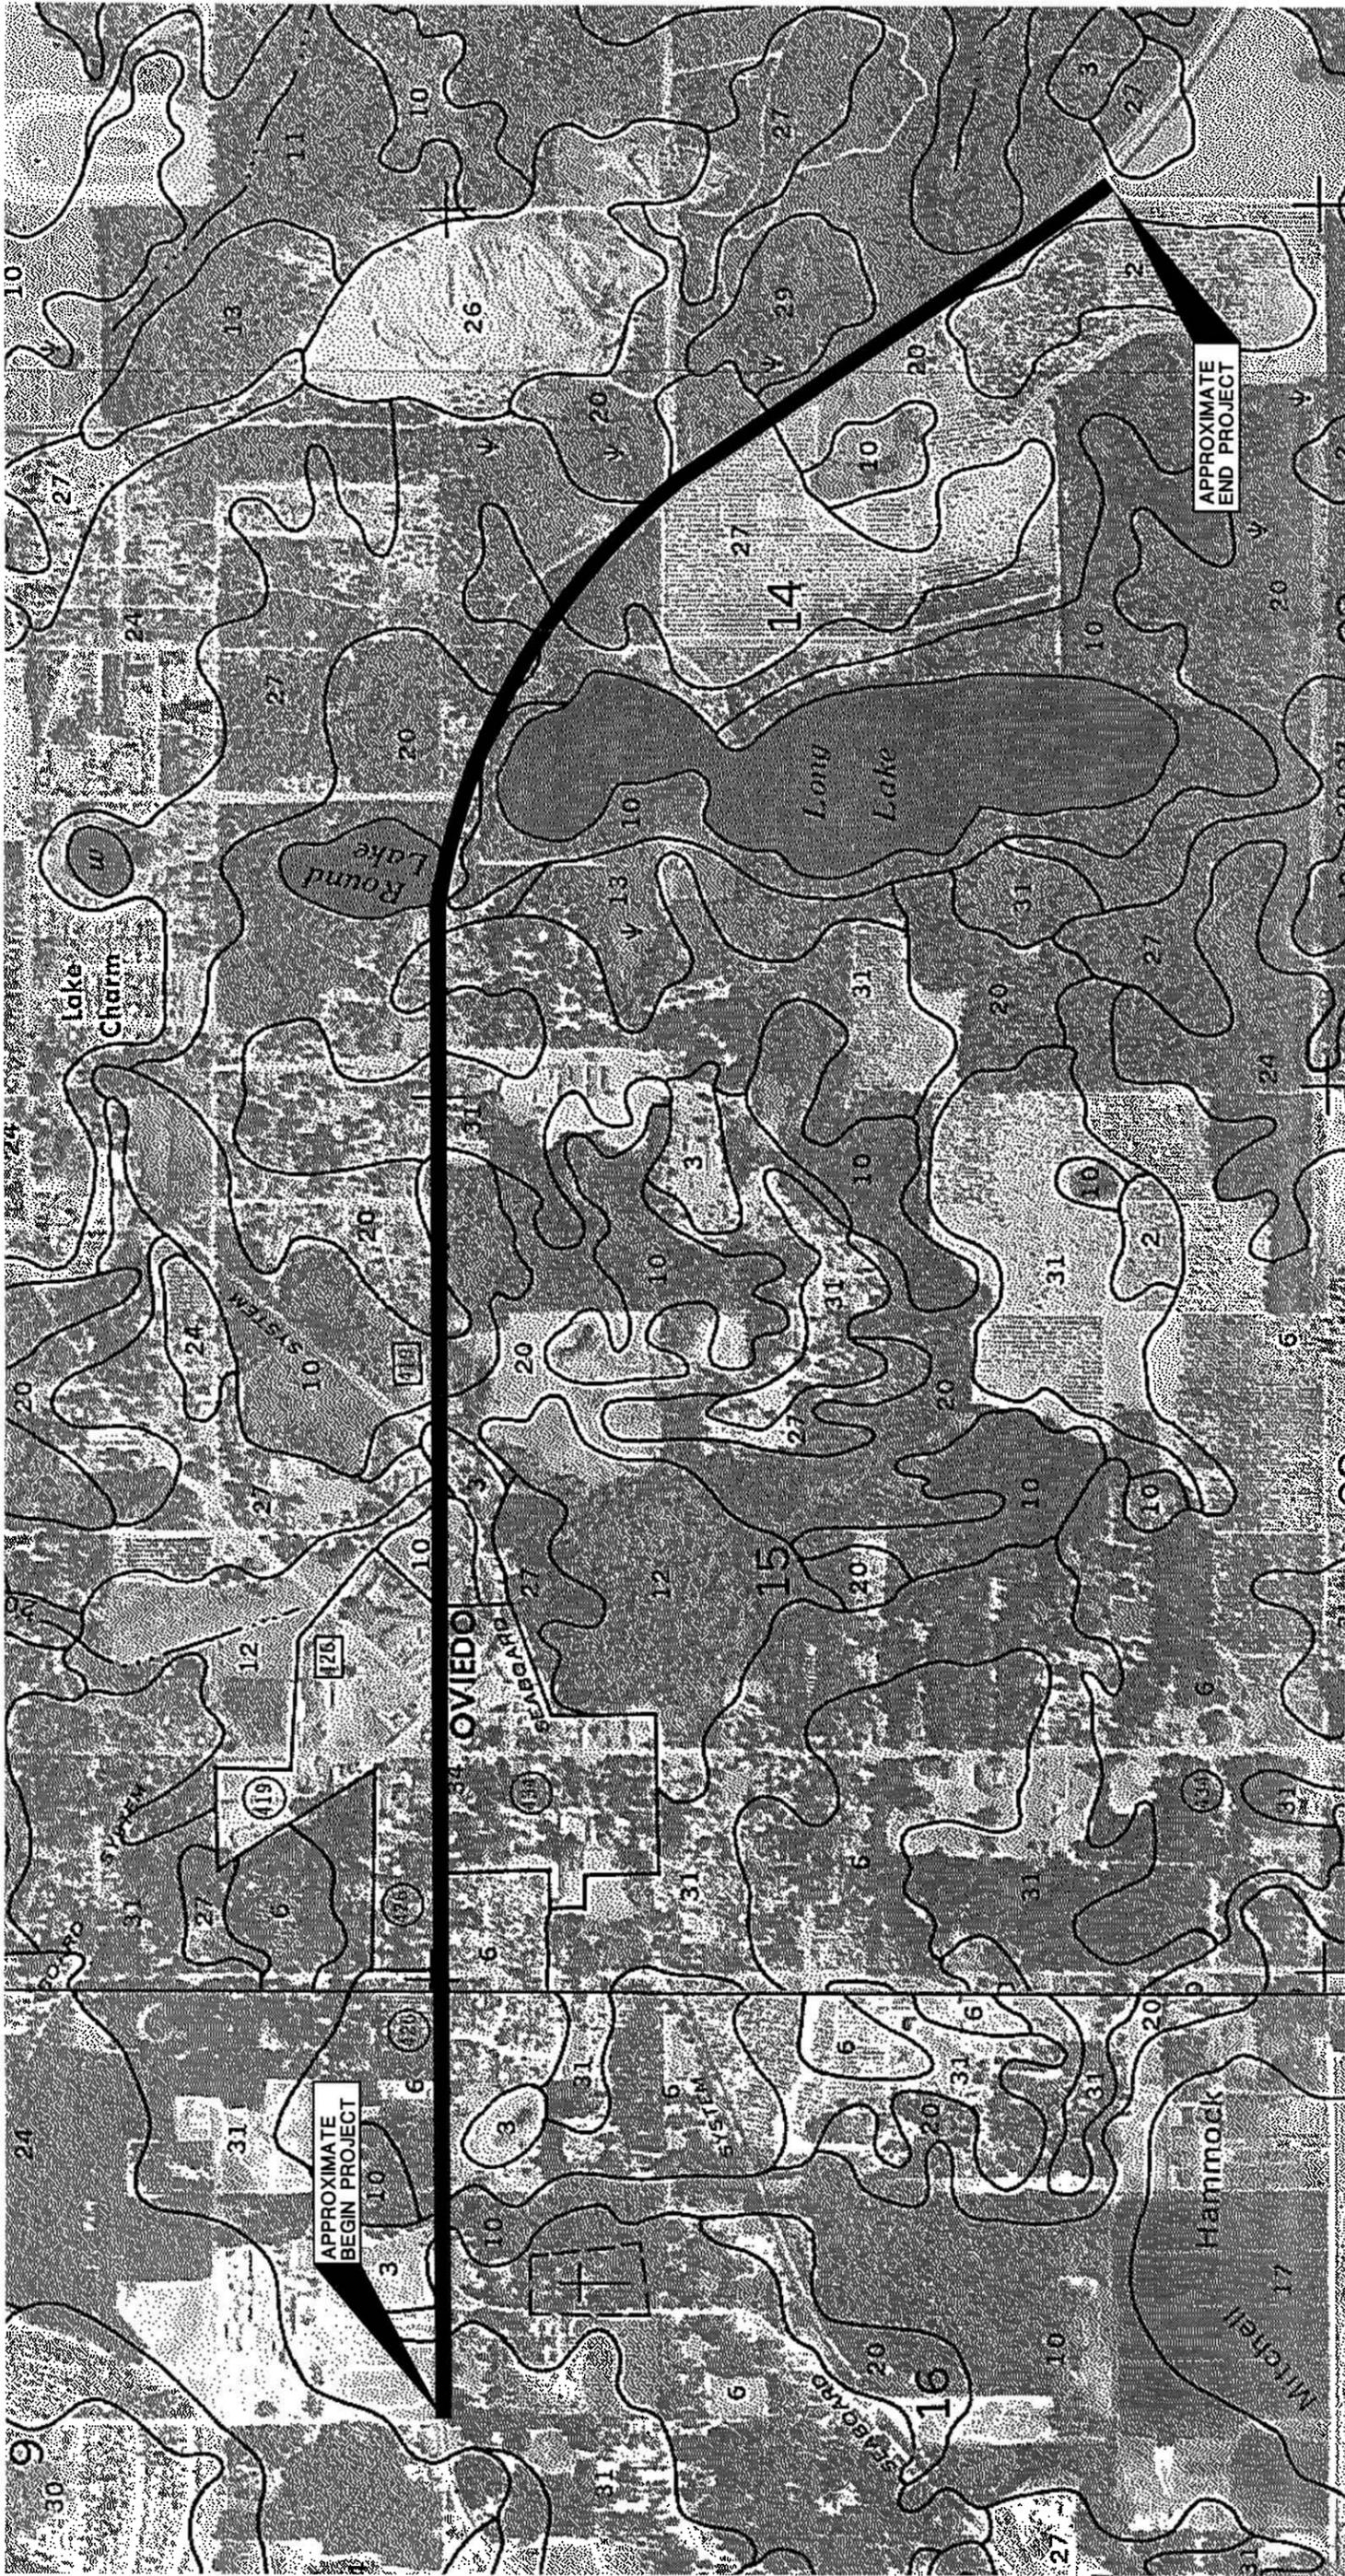
DRAWN BY: CD	CHECKED BY:	DATE: 09/22/03
FILE NO. 02-6521	APPROVED BY:	FIGURE: 2

Based on the 1990 Soil Survey for Seminole County, Florida, as prepared by the U.S. Department of Agriculture Soil Conservation Service, the project corridor encounters various soil types within the project boundaries. The various soil types and a brief description of their characteristics are presented as Table 1. The approximate project location is shown superimposed on a reproduction of the Soil Survey Map presented as Figure 2.

Soil Type	Description
3 - Arents, 0 to 5 percent slopes	Consists of different kinds of soils excavated from several areas. This fill material is the result of earthwork operations and is used to fill such areas as sloughs, marshes, shallow depressions, swamps, and other low-lying areas.
6 - Astatula - Apopka fine sands, 0 to 5% slopes	Nearly level to gently sloping. Surface layer of gray to grayish-brown fine sand 3 to 4 inches thick. A subsurface layer of pale brown to very pale brown fine sand to about 64 inches. Underlying material to about 80 inches consist of very pale brown fine sand and a yellowish brown sandy clay loam.
10 - Bassinger, Samsula, and Hontoon soils, depressional	Nearly level, very poorly drained organic laden soils found in swamps and depressions. These soils consist primarily of organic material (i.e., muck and peat) in varying stages of decay.
12 - Canova and Terra Ceia Mucks	Level, poorly drained organic laden soils found in swamps and depressions. These soils consist primarily of organic material (i.e., muck and peat) in varying stages of decay.

27 - Pomello fine sand, 0 to 5 percent slopes	Nearly level to gently sloping, moderately well drained sandy soil found on low ridges and knolls of the flatwoods. A surface layer of light gray fine sand overlying white, black, dark brown, and brown fine sands.
31 - Tavares-Millhopper fine sands, 0 to 5 percent slopes	Nearly level to gently sloping. A surface layer of dark grayish brown and gray fine sand to about 7 inches. The subsurface layer to a depth of about 45 inches is very pale brown and pale brown fine sand. Underlying soils consists of yellowish brown and white fine sand and light gray sandy clay loam.
34 - Urban land, 0 to 12 percent slopes	This miscellaneous area is covered by urban facilities, such as shopping centers, parking lots, industrial building, etc. The natural soil can not be observed. Soils in unoccupied areas consist of various type soils. These soils have been altered by grading and shaping, or fill has been used to cover these soils.

OBTAINED FROM: SOIL SURVEY OF SEMINOLE COUNTY, FLORIDA  
 ISSUED DATE: MARCH 1990

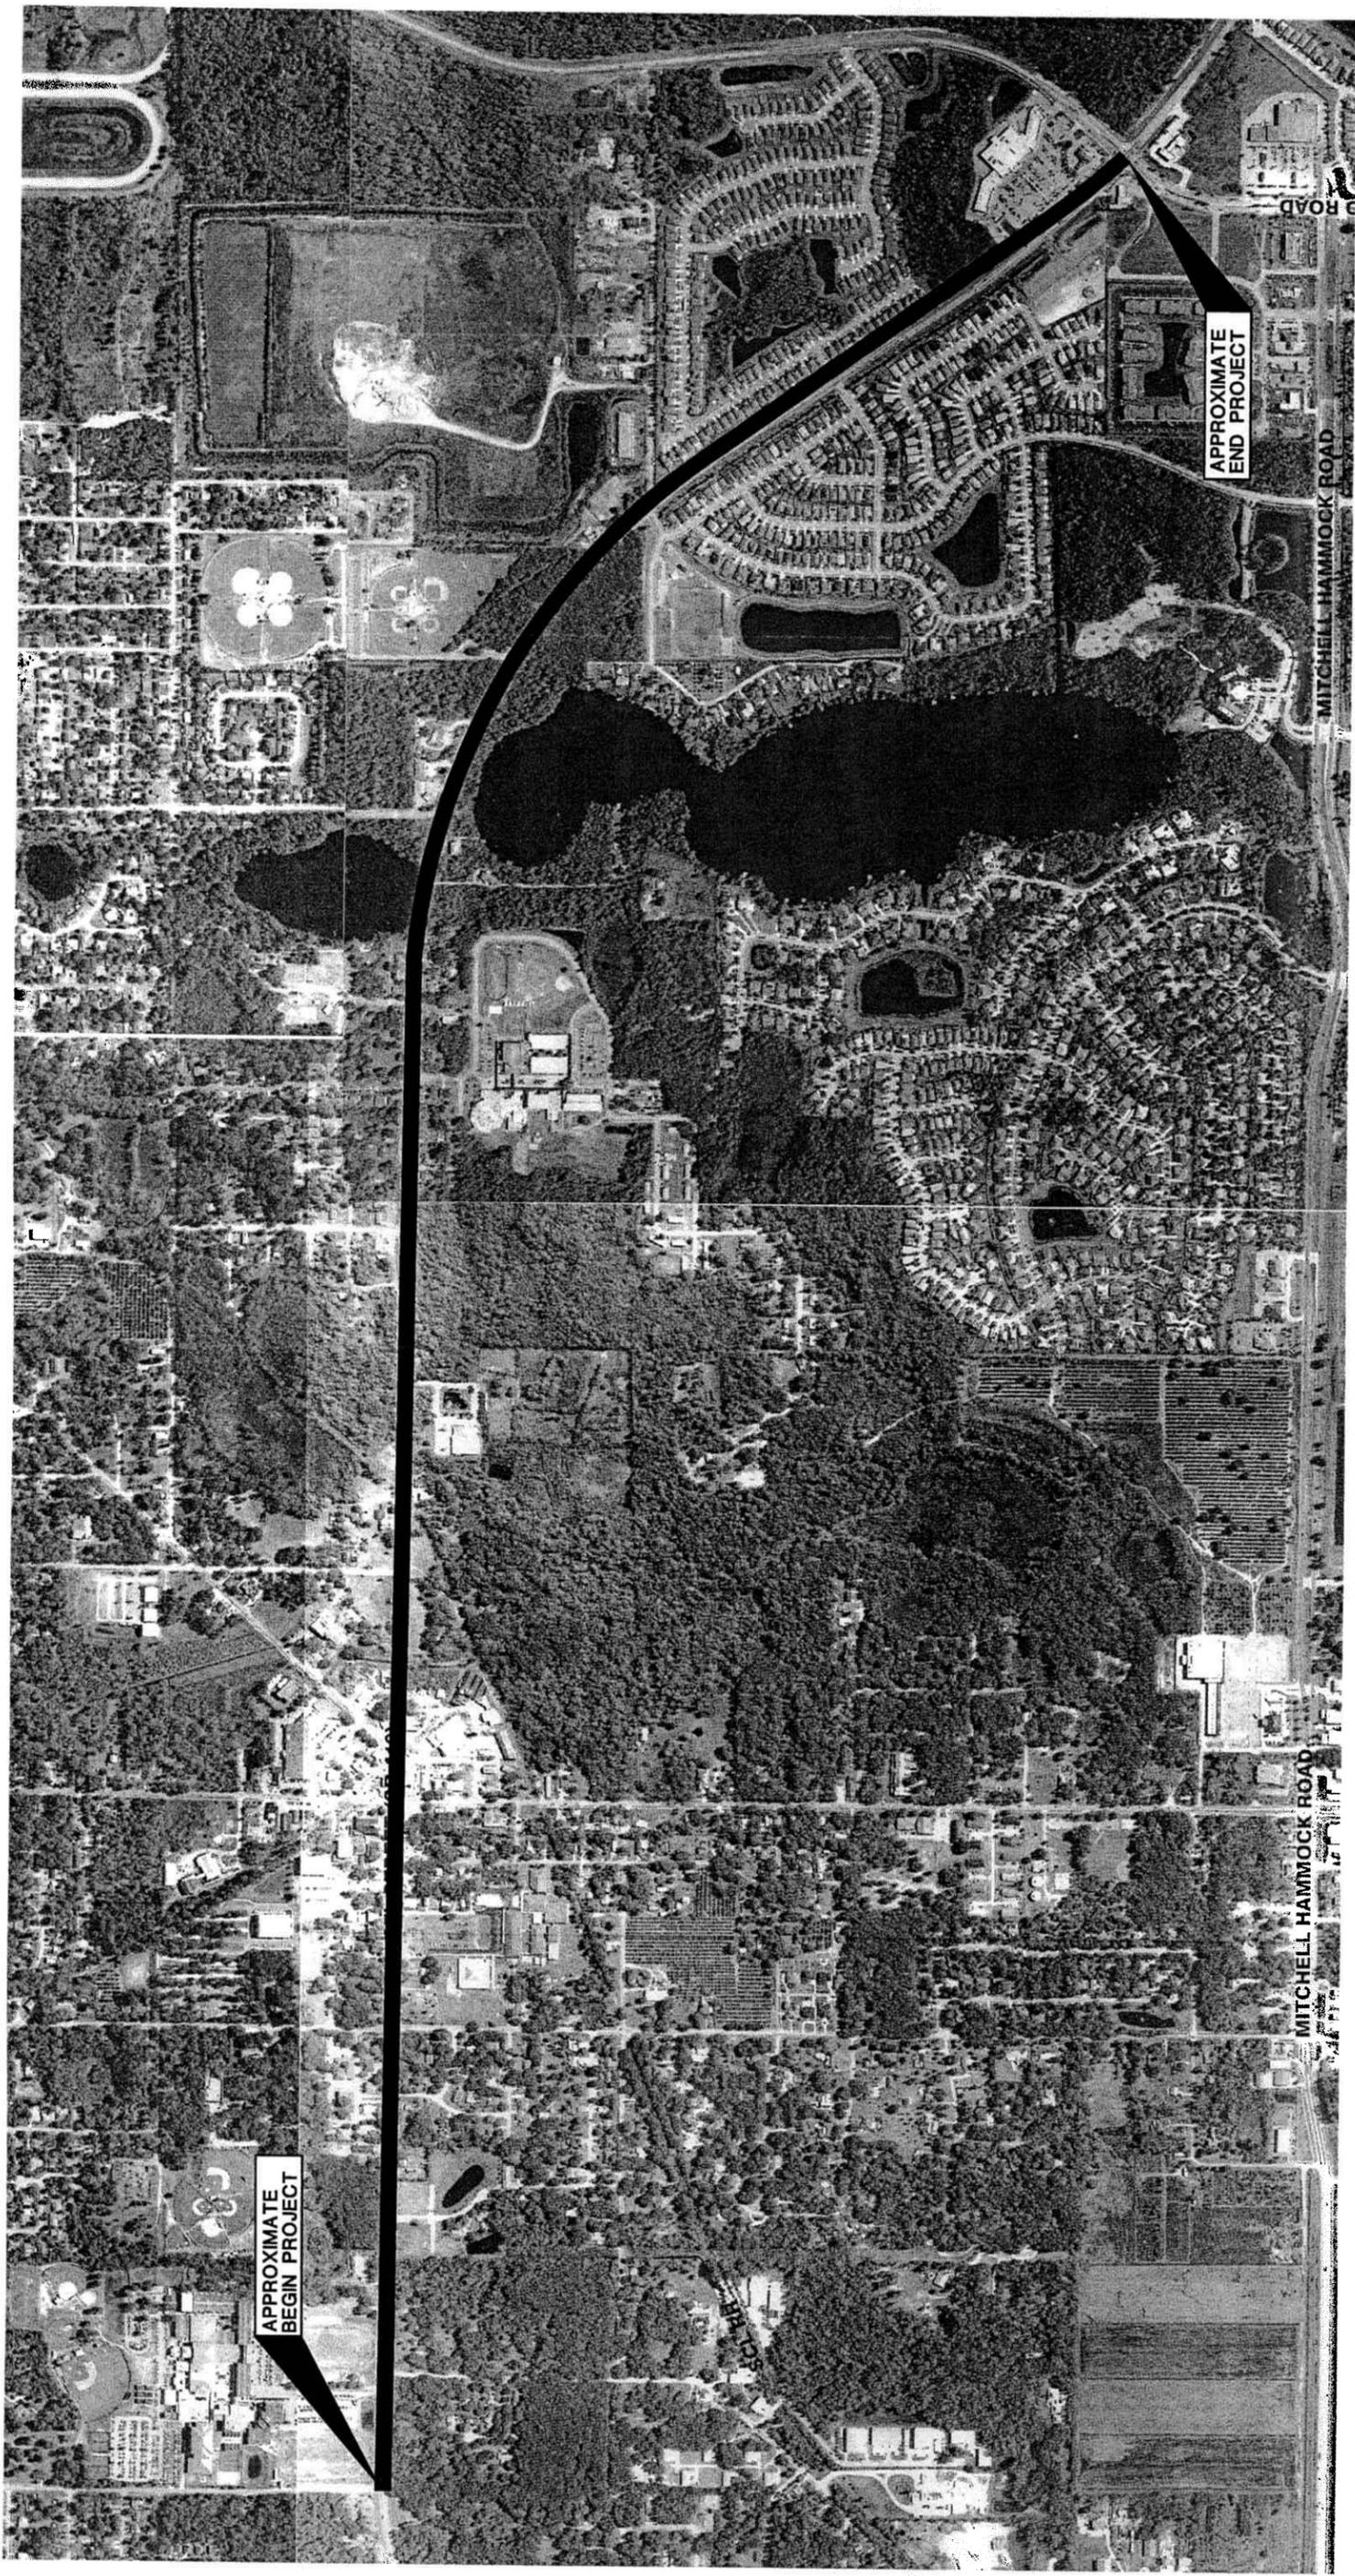
DRAWN BY: CD	CHECKED BY:	DATE: 09/22/03
FILE NO. 02-6521	APPROVED BY:	FIGURE: 3

Field observations of the project corridor and adjacent properties were performed between August 29 and September 14, 2003. Photographs taken during our field visits are included in Appendix I. A 2002 aerial photograph of the project corridor is included as Figure 3.

OBTAINED FROM AERIAL PHOTOGRAPH: SEMINOLE COUNTY, FLORIDA  
 PHOTO DATE: JANUARY 2002

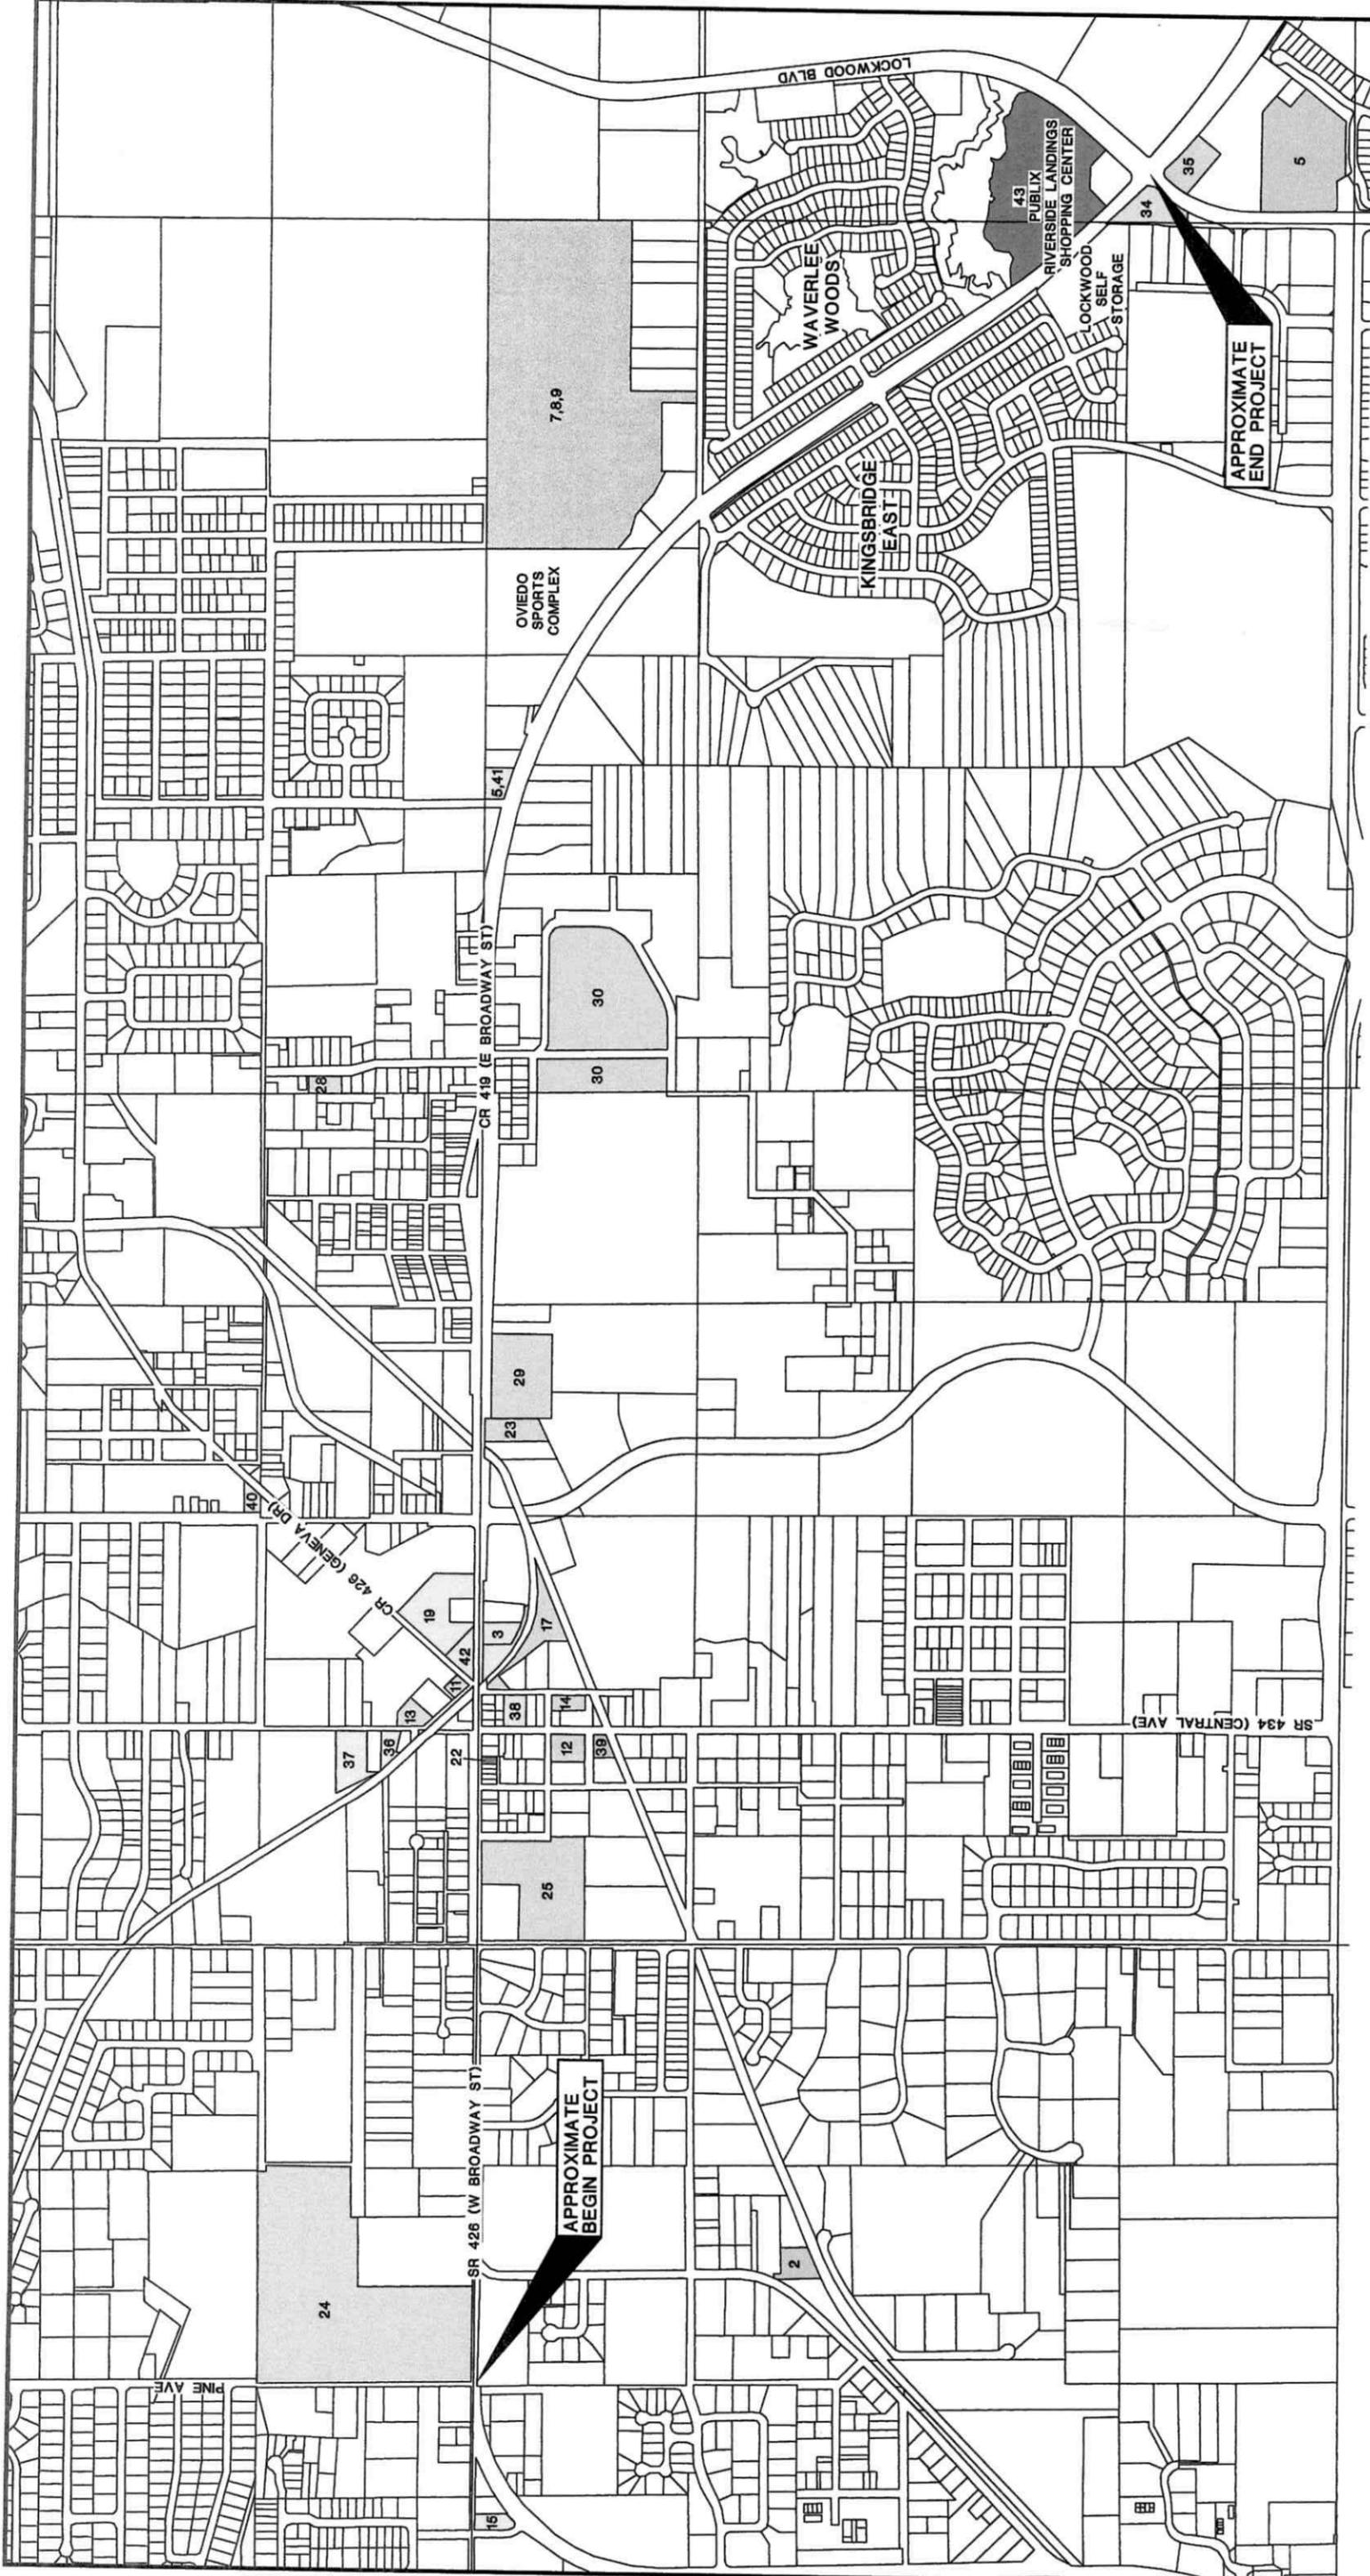
**POTENTIALLY CONTAMINATED  
PROPERTIES ALONG PROPOSED  
RIGHT OF WAY**

<sup>3</sup> Location of facility as depicted on Figure 4.

Facility ID	Facility Name	Facility Address	Discharge Date(s) <sup>1</sup>	Score <sup>2</sup>	Map No. <sup>3</sup>
<sup>1</sup> Only facilities with reported discharges (based on review of the SCTM database) have discharge dates. <sup>2</sup> Only facilities registered in one of the State cleanup programs have a priority score. <sup>3</sup> Location of facility as depicted on Figure 4.

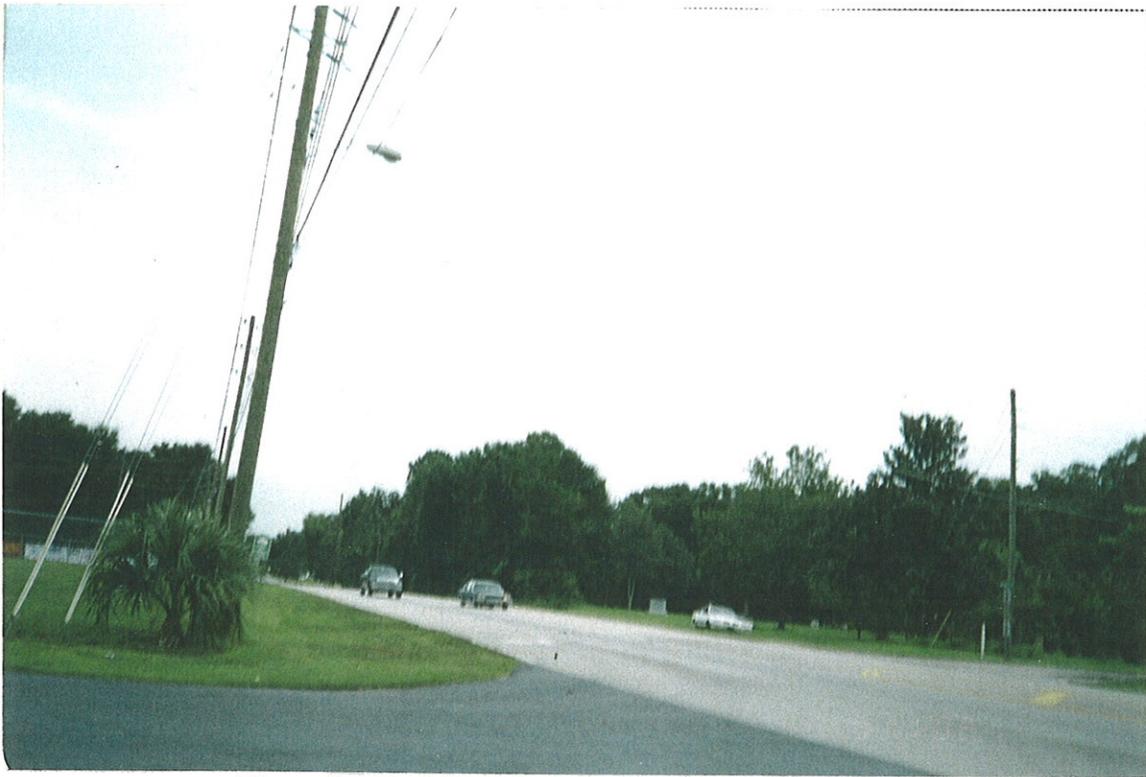
View of project corridor facing east from intersection of Pine Avenue and State Road 426.

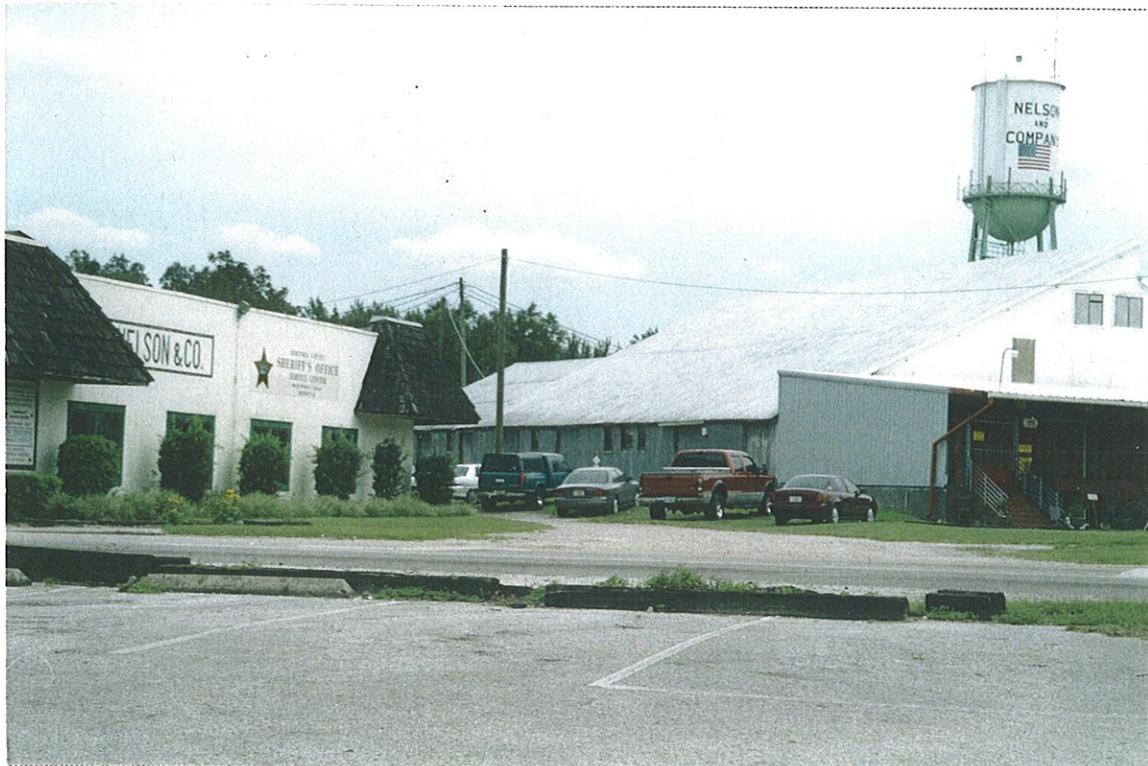
We note that there were no open RCRA hazardous waste generator files at DEP's Central Florida District office available for our review for the Nelson & Co. facility located at 110 East Broadway Street and the Star Enterprises facility (currently Texaco #24-025-0189) located at 1045 East Broadway Street. However, both facilities are listed in DEP's Stationary Tank and Contamination Monitoring database as possessing underground petroleum storage tanks. These facilities are further discussed in the following section of this report.

View of Nelson & Co., facility located at 110 East Broadway Street.
